Two men die in crash while fleeing Police in Wellington

IPCA: 23-17326

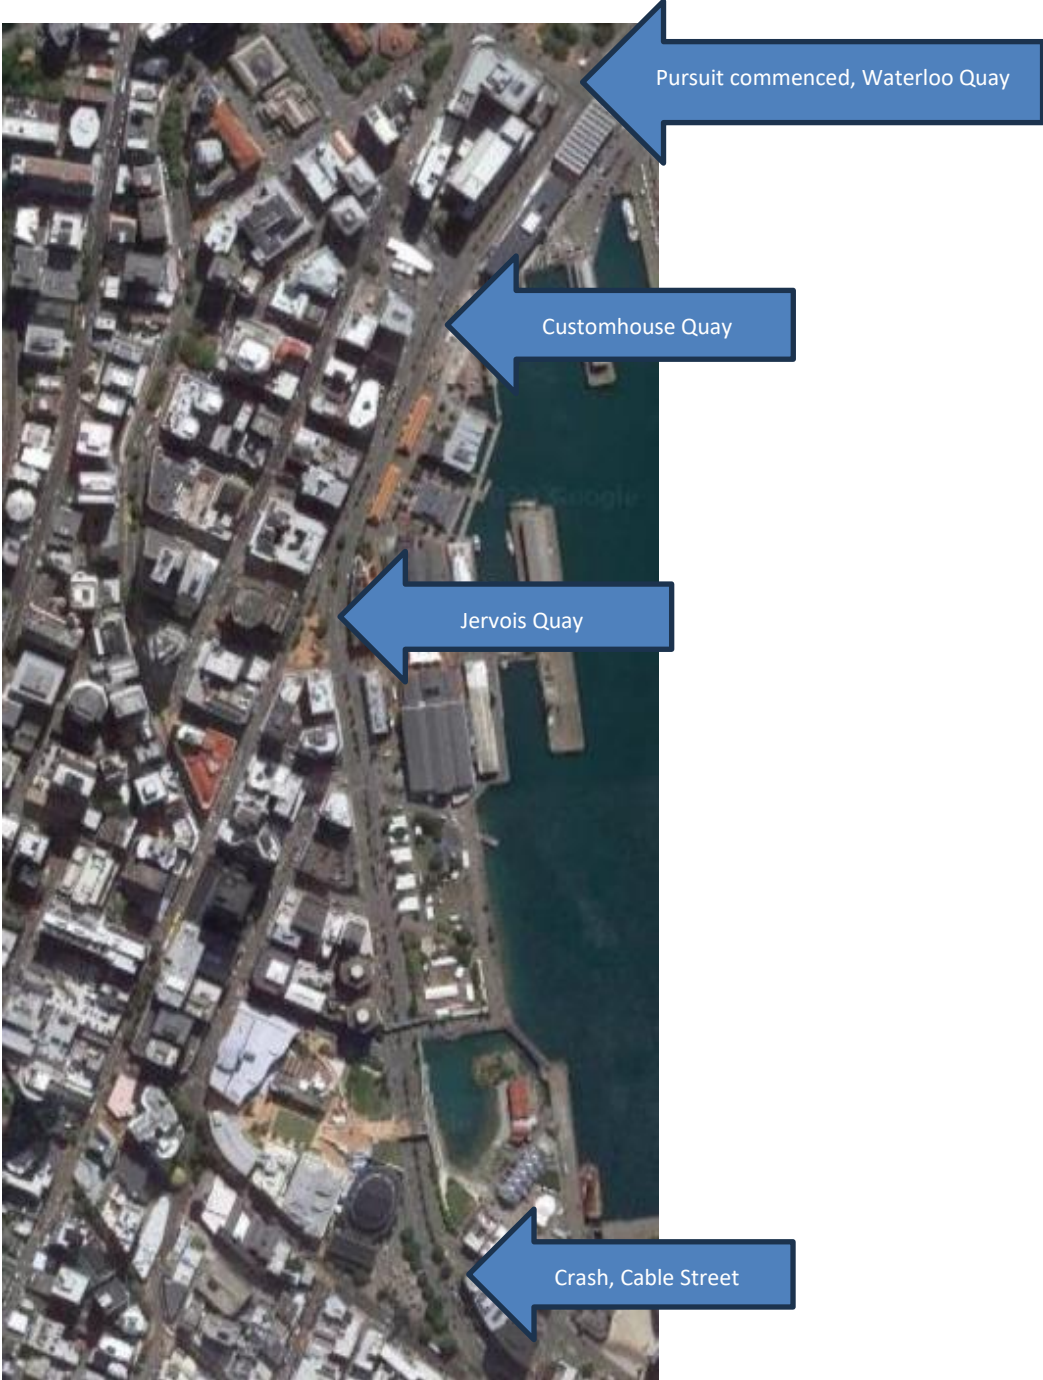
Appendix 1 – Route of Pursuit

10. The area they were driving in Wellington is known as ‘the quays’, which runs adjacent to the waterfront. Waterloo Quay changes into Customhouse Quay with a slight left turn on the traffic light intersection with Whitmore Street. Customhouse Quay is 250 metres long and changes into Jervois Quay with a slightly sharper left turn at the traffic light intersection with Brandon Street. Jervois Quay runs for 600 metres and changes into Cable Street with a still sharper left-hand corner.² It was at this corner where the Mazda left the road and crashed into a building.
